CASE STUDY 06

Safeguarding history at Kirby Knowle Castle:

A GEOTECHNICAL CASE STUDY

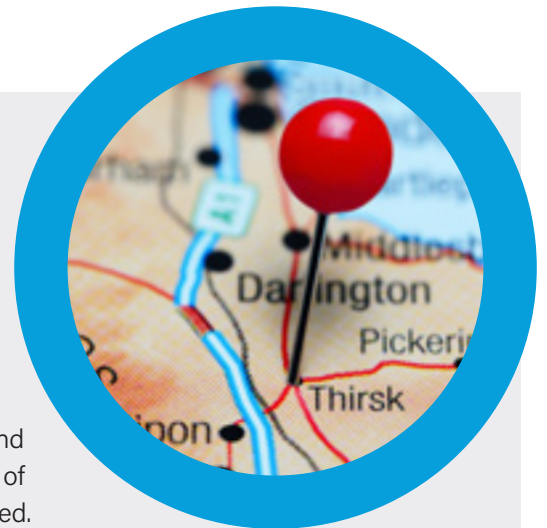
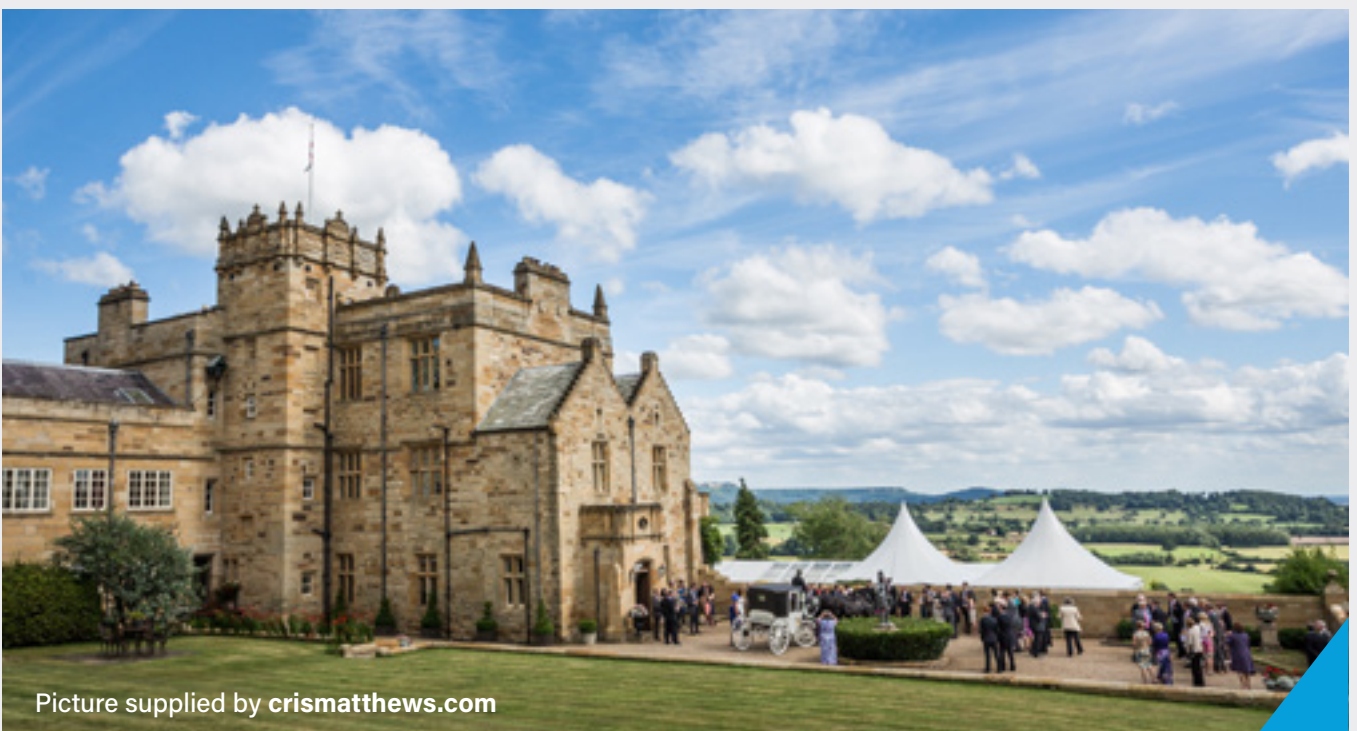
This magnificent building is now the private residence of **David Kempley**, and in December 2019, he faced a significant problem. After a prolonged period of heavy rainfall, the retained slope at the south east corner of the rampart failed.
