CASE STUDY 04

Subsidence & Failing Retaining Wall

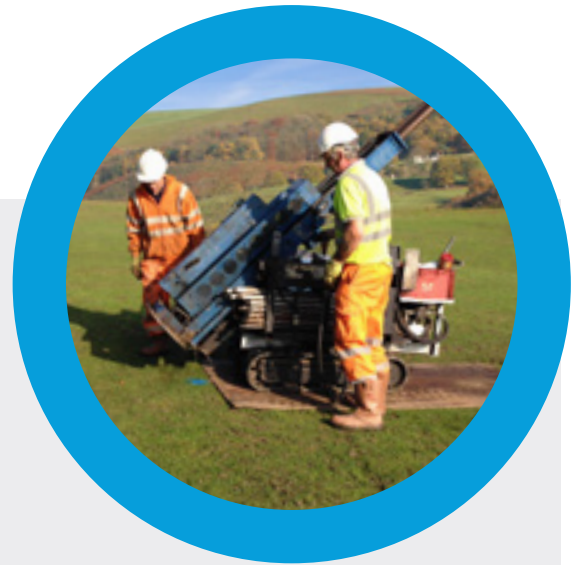
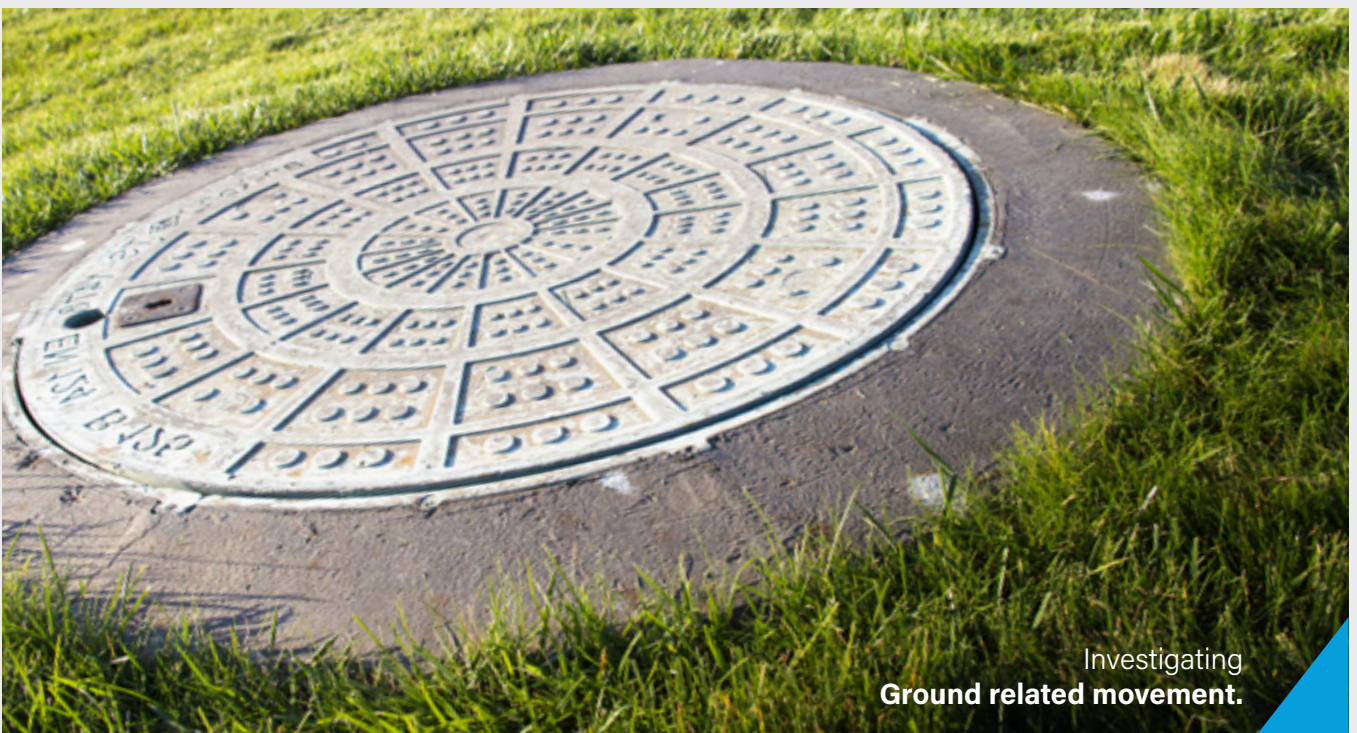
To investigate ground related movement to a boundary masonry retaining wall and pre-cast concrete paving slab footpath adjacent to the full length of the side elevation of a house that was exhibiting a pronounced tilt downward towards the boundary retaining wall.

The cover and frame to the foul water drain inspection chamber to the central area of the elevation appeared to also similarly tilt down towards the boundary retaining wall.

Investigating
Ground related movement.

- Interpretation of the data provided by the site investigation determined that the mode of failure in this case a layer of peat present below the clay bearing strata upon which the retaining wall foundation was placed.

- The investigation and enquiries with the client has shown that the house, which was constructed before the retaining wall, has been piled. However the retaining wall was constructed by excavating until "suitable" ground conditions were revealed by the builder/contractor. This did not reveal the underlying weak peat layer present below the firm clay on which the wall has been founded.

- In addition the retaining wall appeared to be rotating around a central point, and a line of conifers was present at one side of the wall. It was initially thought that the mode of failure was attributed to shrink/heave caused by the conifers. However after the peat was revealed it was evident that the whole length of wall was most likely subject to settlement, and that the conifers, through dewatering of the peat, were inducing differential settlement causing the wall to exhibit cracking.
