CASE STUDY 06

Safeguarding history at Kirby Knowle Castle:

A GEOTECHNICAL CASE STUDY

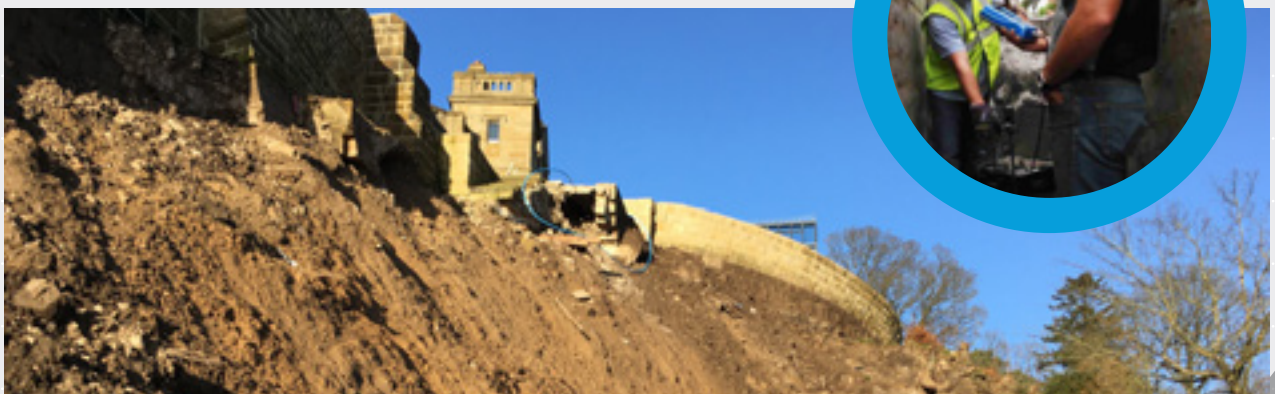
Table 2: Geotechnical Report Summary

Item	Comments
Problem	Large landslide immediately adjacent to the ramparts.
Geology	Solid geology comprises Dogger Formation (sandstone) over Whitby Mudstone Formation (mudstone).
Historical Landslides	There are several landslides within the same geological sequence. Published data from these failures have been reviewed.
Strata Conditions	Generally made ground or disturbed ground over the weathered fraction of the Whitby Mudstone Formation (recovered as clay). On the higher ground the weathered fraction of the Dogger Formation was encountered, which was recovered as silty sand.
Groundwater	No obvious water strikes recorded - Soil at various horizons was found to be wet (ie water softened).
Modes of Failure	There are three main forms of landslide observed at this site. <ul style="list-style-type: none">■ A significant wedge type failure to the east of the south east corner of the ramparts.■ Rotational failure to the north of the wedge failure.■ Transitional landslide, developing into a flow, to the south of the wedge failure
