CASE STUDY 05

A Tale of **Three Slopes**

Investigating the causes of failed slopes
The impact of river bank stability.

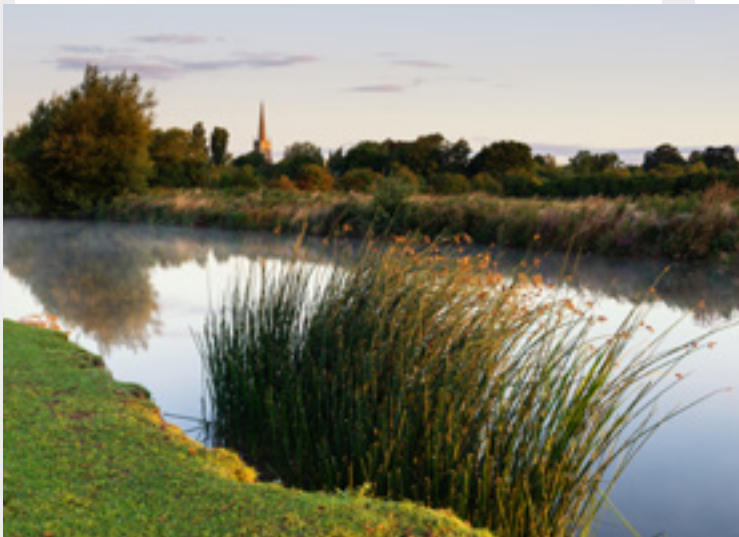
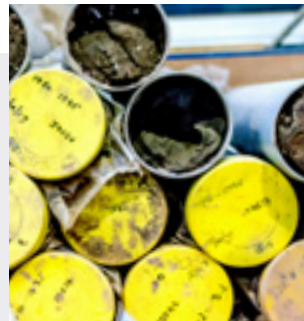
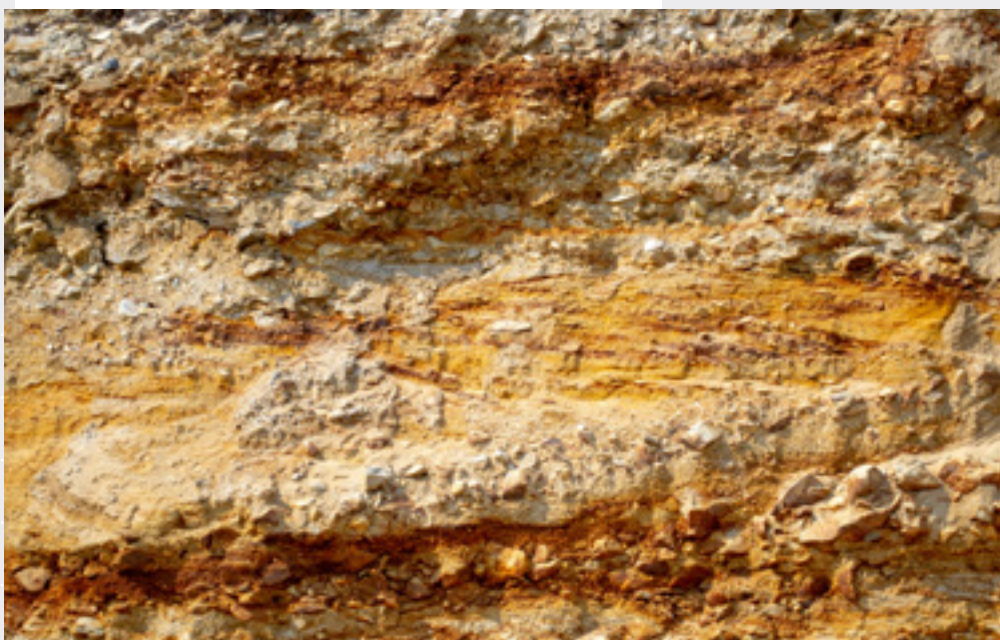
- Cases 1 and 2 were on the outside of bends on the River Ure (1) and River Wharfe (2). At both locations there was a narrow alluvial flood plain and a river bank up to the subject properties, which were situated on higher ground.

In both cases, levees had been constructed on the opposite side of the river which channelised flow and protected the adjacent floodplain.

- Case 3 was associated with the back gardens of three properties that had been constructed on a flood bank, which slopes down to a berm then down to a flood alleviation dyke, which enters the River Wharfe via a sluice.

Case 1: The trigger for failure was the presence of the levee on the opposite side of the river as this increased the level of water during flood episodes. As the underlying soils are permeable in nature, water was able to enter the slope.

When the flood level subsequently reduced, water flow through the very silty fine sand resulted in a phenomenon known as running sand, thus toe support to the slope was gradually removed such that slumping and progressive failure of the slope occurred, which regressed up the slope.

Case 2: At this site, the more sensitive fine granular soils were present beneath a capping of less permeable soil, comprising very silty clay. Therefore, the groundwater regime would not be adversely affected by short term flood episodes. However, at this site it was known that a water main had burst and the water was entering the underlying silts via a gully, which resulted in an imbalance in the groundwater profile and failure of the otherwise marginally stable bank ensued.

Case 3: Similar soils were present at this site and it was known that a surface water outfall pipe between two of the properties had failed. This would suggest a similar mechanism for failure as Case 2. However, at this site there was a timber king post wall supporting the bank of the dyke.
